CASE STUDY. CONVEYOR BRIDGE REMOVAL, SCOTLAND - 2017

PROJECT: *Dismantling of a Sealed Conveyor Bridge over Glenmuir River.*

LOCATION: *Duncanziemere Site, Nr. Logan, New Cumnock, Scotland*

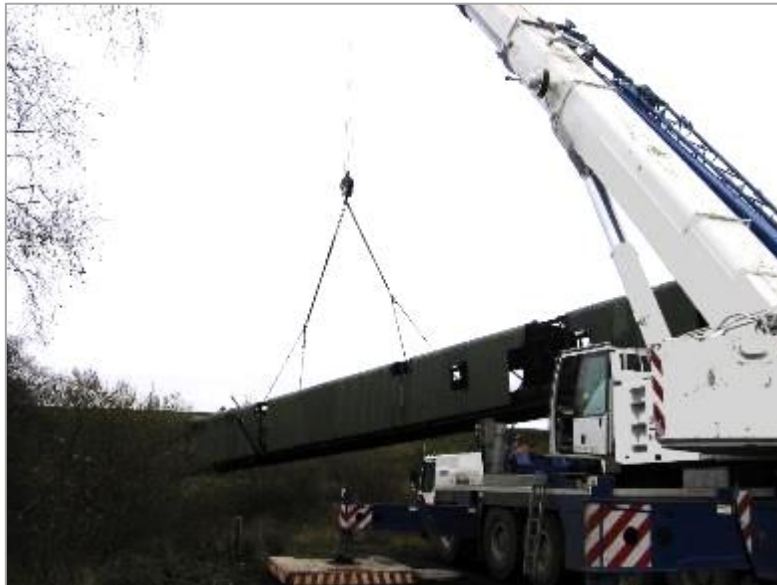
Euro Demolition & Dismantling have successfully completed the stripping and dismantling of a 70 metre long coal conveyer bridge at a site in New Cumnock, Scotland in November 2016.

The bridge was hot cut into 3 sections, and crane lifted from site.
